Reserve Study Level I

Tilghman on the
Chesapeake - Marina

REPAIR & REPLACEMENT RESERVE REPORT

Project #323140

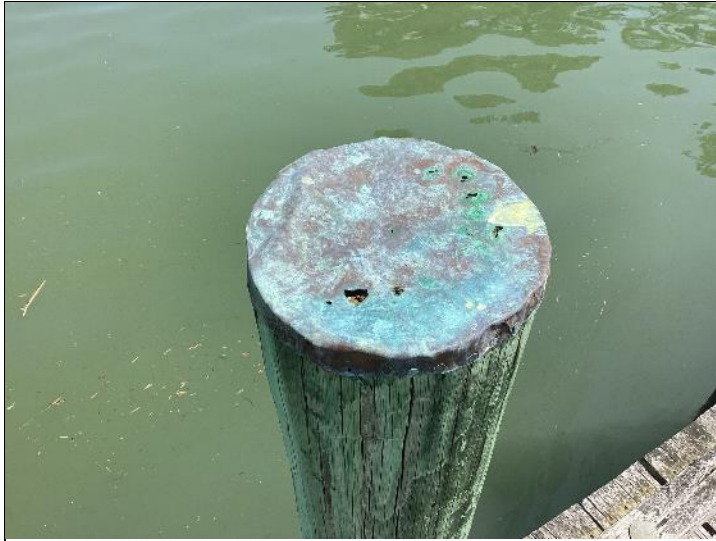
Photo #1: Some of the piling caps have deteriorated and should be considered for replacement to help preserve the wood.

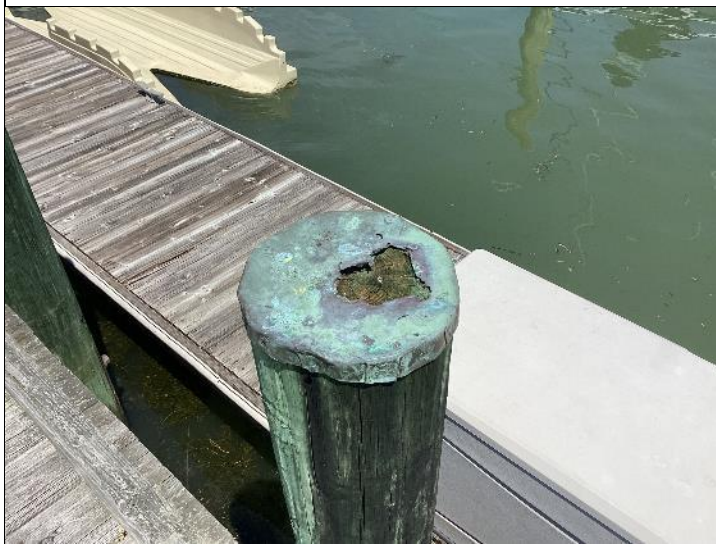
Photo #2: Some of the piling caps have deteriorated and should be considered for replacement to help preserve the wood.

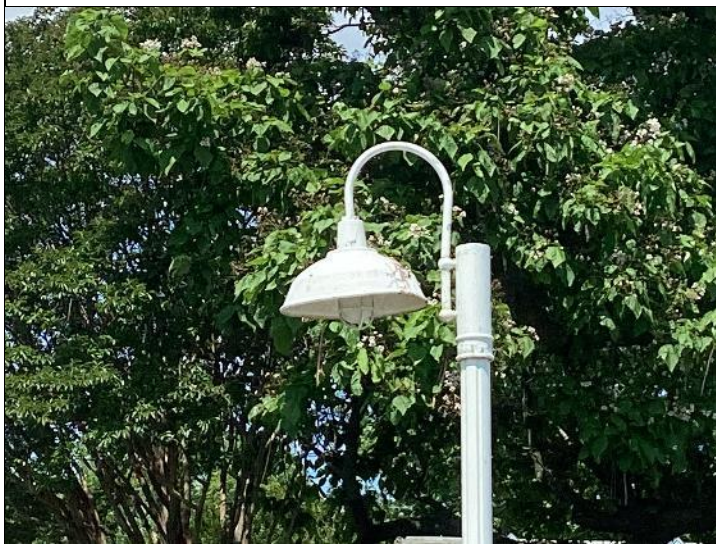
Photo #3: Typical pole light.

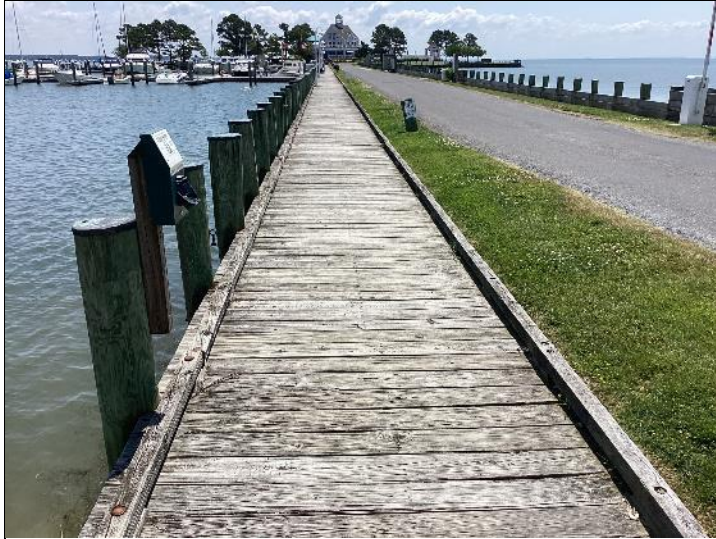
Photo #4: Boardwalk.
Consideration should be given to sealing the decking with a wood preservative to help make it last.

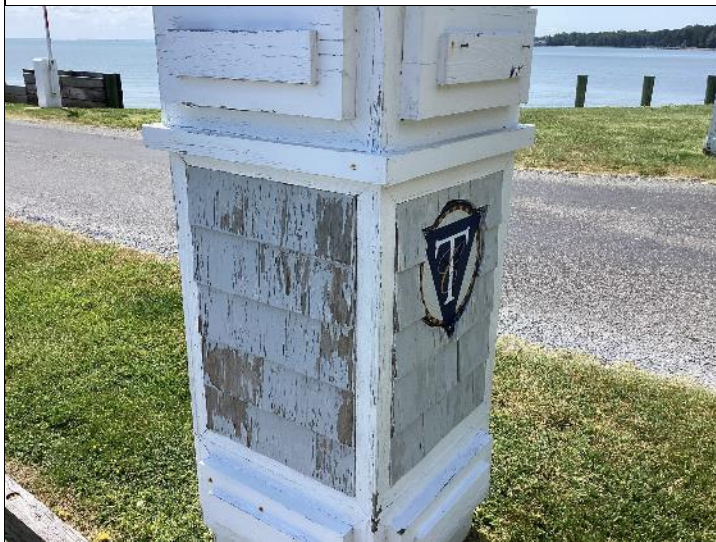
Photo #5: We recommend the entry columns be reconditioned.

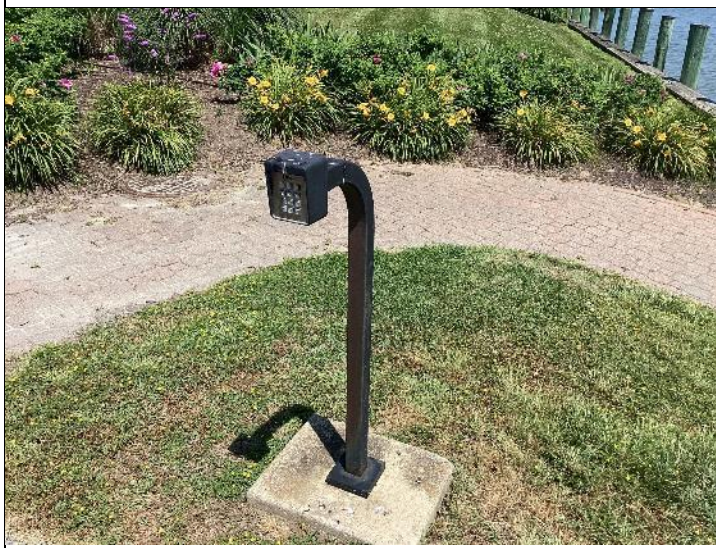
Photo #6: Entry gate arm keypad. We recommend the metal post be properly prepared and painted to preserve the metalwork.

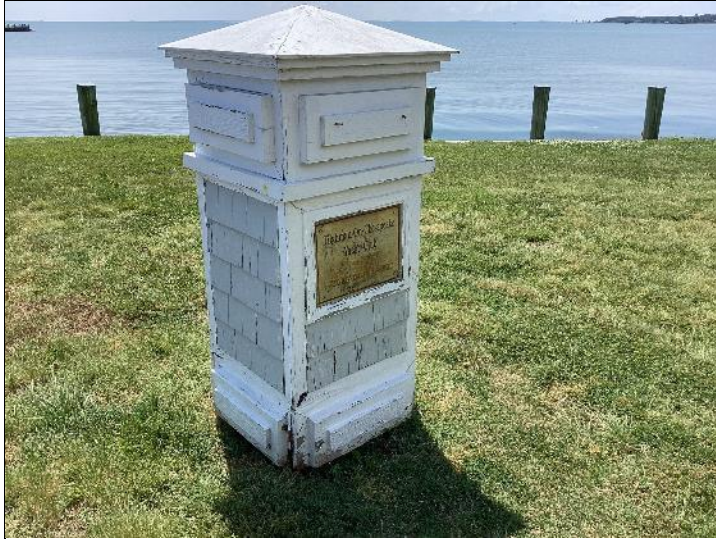
Photo #7: We recommend the entry columns be reconditioned.

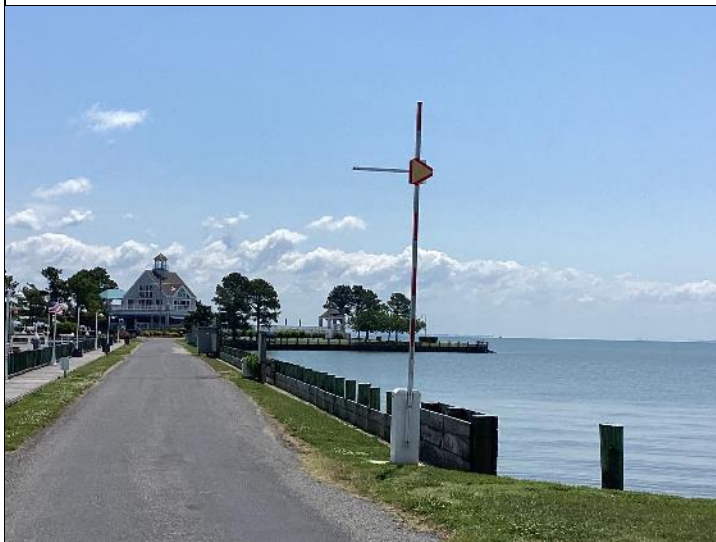
Photo #8: Entry gate arm.

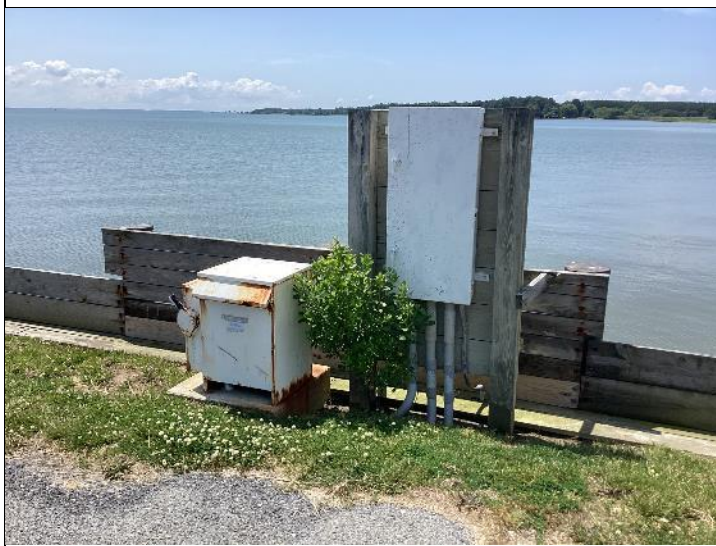
Photo #9: Transformer

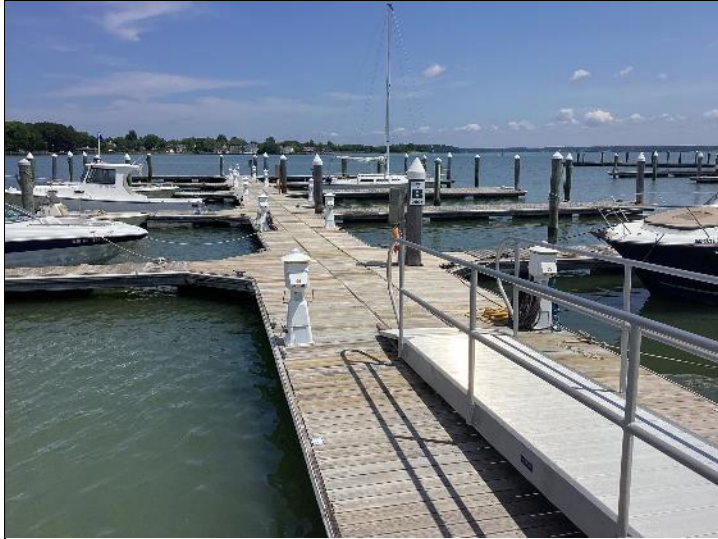
Photo #10: Typical dock.

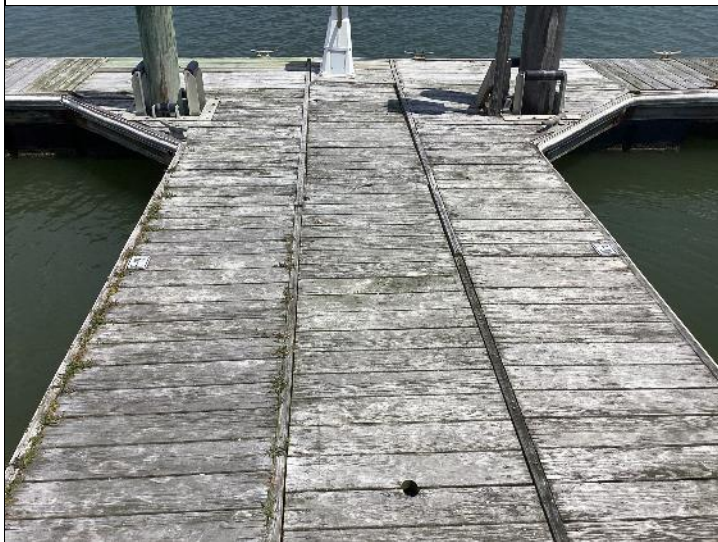
Photo #11: Deterioration noted in the dock decking. This can be sectionally repaired overtime or replaced all at once.

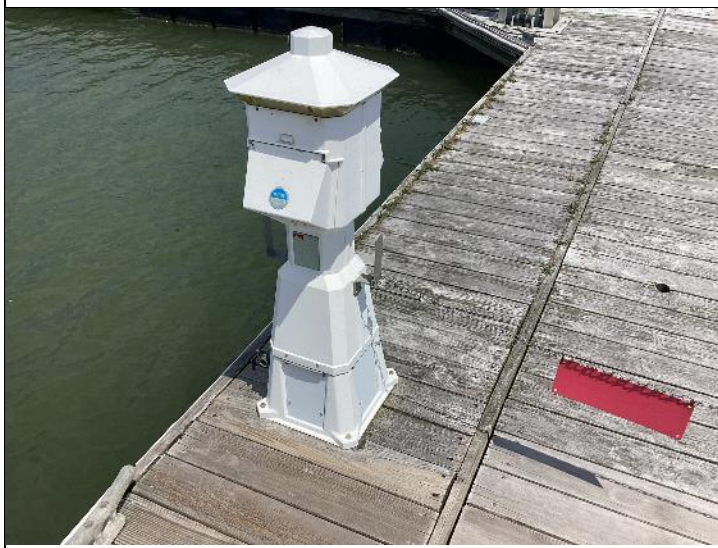
Photo #12: Dock power pedestal.

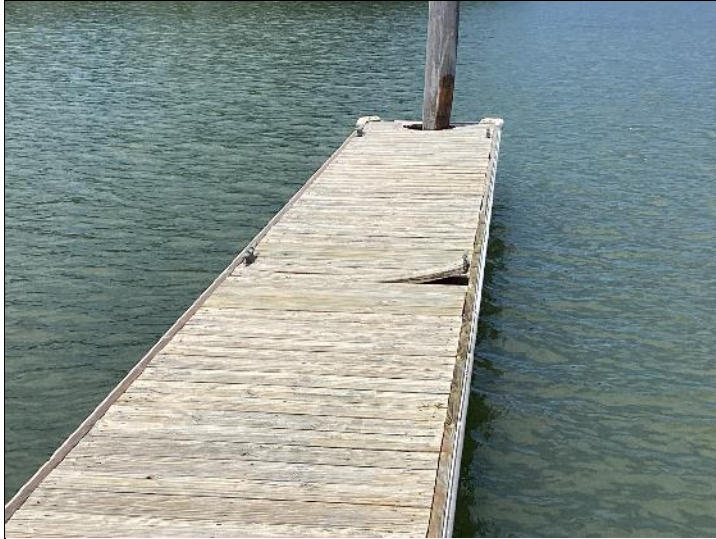
Photo #13: Some boards have warped and require replacement.

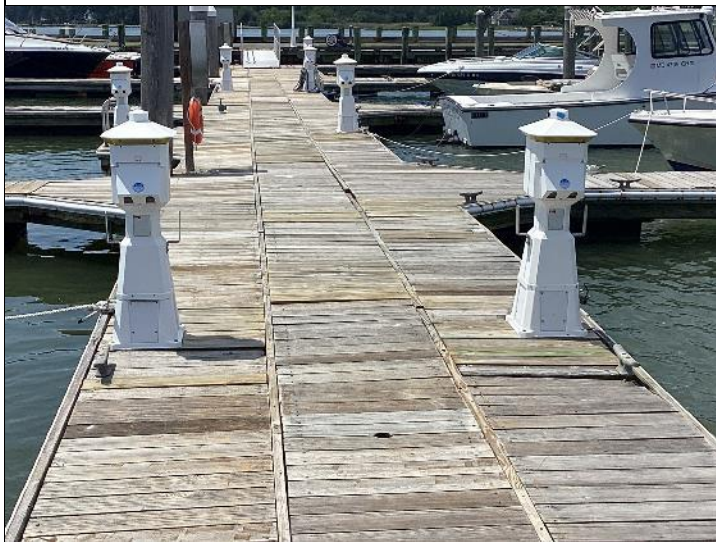
Photo #14: Deteriorated boards should be replaced where needed.

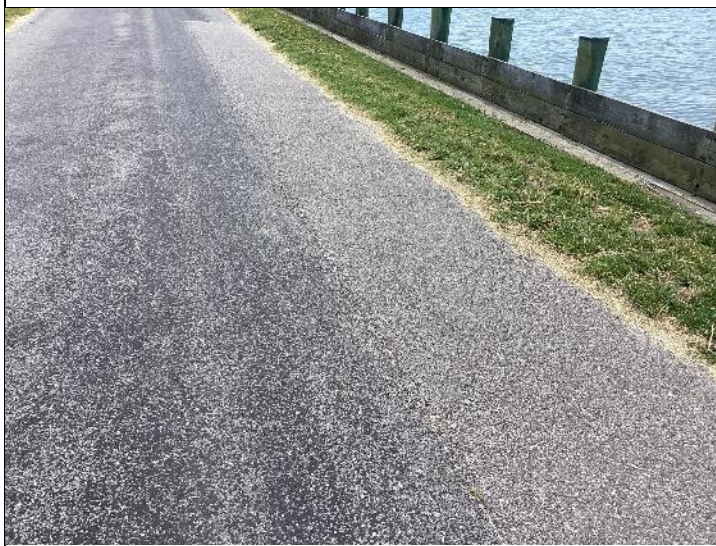
Photo #15: The asphalt was in poor condition during our review. We recommend cracks be maintained sealed to prevent displacement of the subbase.

Chart Item	Repair/Replacement Description
1. Asphalt – Mill & Overlay	The estimated replacement cost in the asphalt section represents the cost to remove all loose materials from existing surfaces, and repair alligating and potholes. Deteriorated areas should be removed with a minimum of a 4" base to reach firm support. The removed areas should extend at least 1' into good pavement outside the damaged areas. It is expected that about 10% of the loose asphalt material will require this type of removal; holes will require being backfilled with dense graded hot asphalt plant mix; and a topcoat will be required to be applied to vertical surfaces. Large cracks will be cleaned and filled with fine sand and asphalt mix. After all surfaces are prepared, a new application of 2" asphalt topping should be applied.

2. Asphalt – Crackfill & Sealcoat	The estimated cost for asphalt sealcoat includes the preparation of the asphalt surface to include crack filling and the application of a sealcoat to the surfaces. Properties use sealcoating to enhance the property. The sealcoat will not extend the life of the asphalt within sound condition.

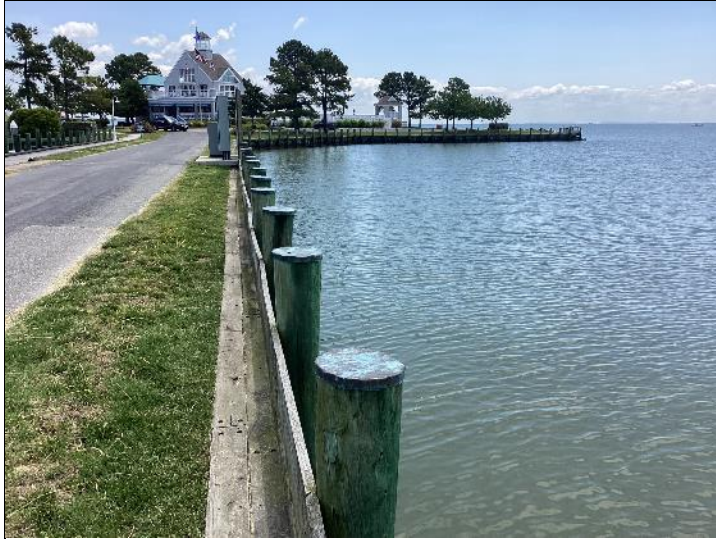
Photo #16: The bulkhead will be replaced sectionally overtime.

17. Bulkhead - Allowance	The estimated replacement cost is for complete removal and replacement of the wood bulkhead system. Because of the extent of the bulkhead, it is not anticipated that total replacement will occur at one time. As such, this line item should be viewed as a draw fund to make replacements to the bulkhead as needed.

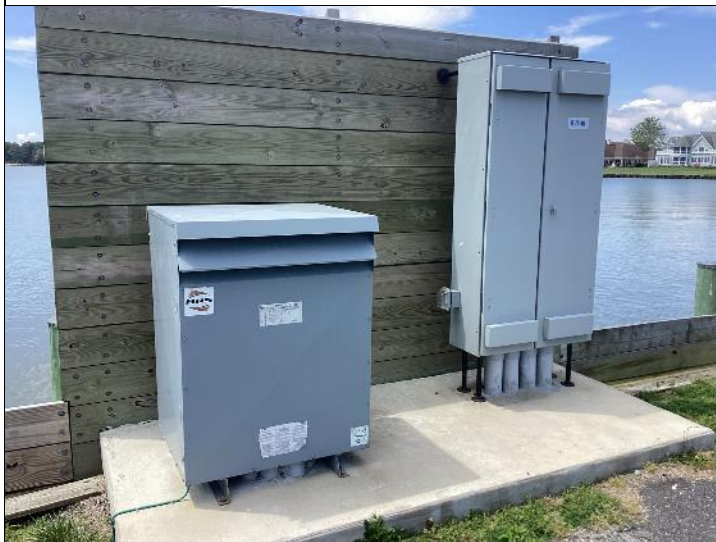
Photo #17: Site transformer.

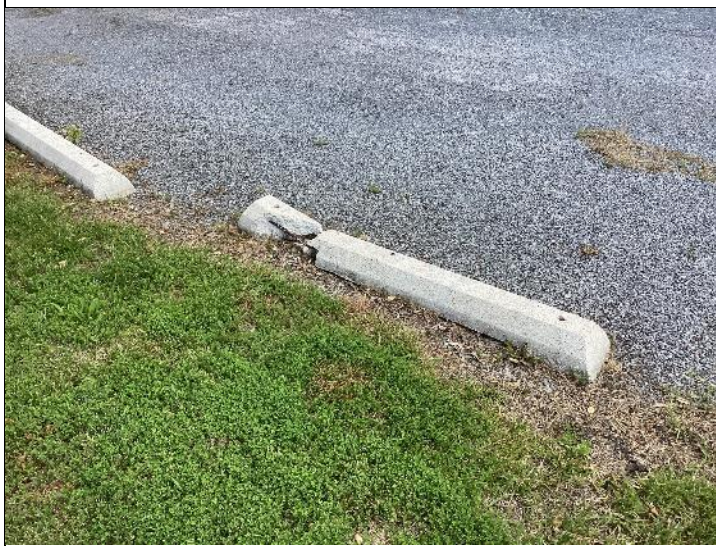
Photo #18: Damaged concrete wheel stop.

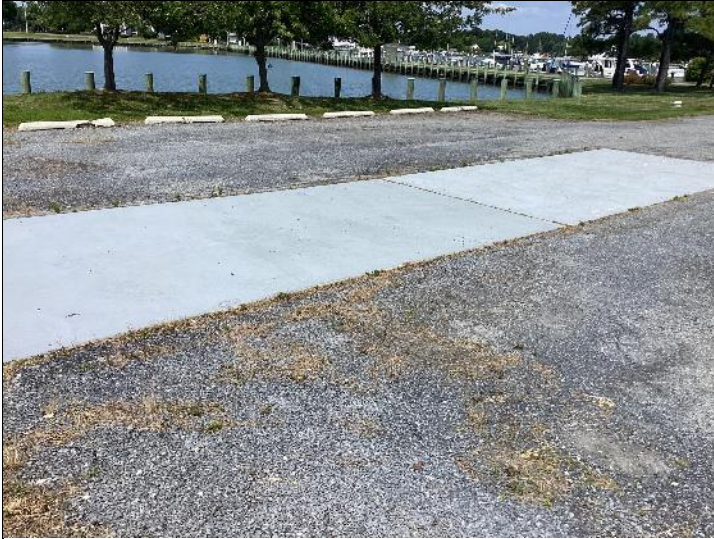
Photo #19: Concrete drive pad.

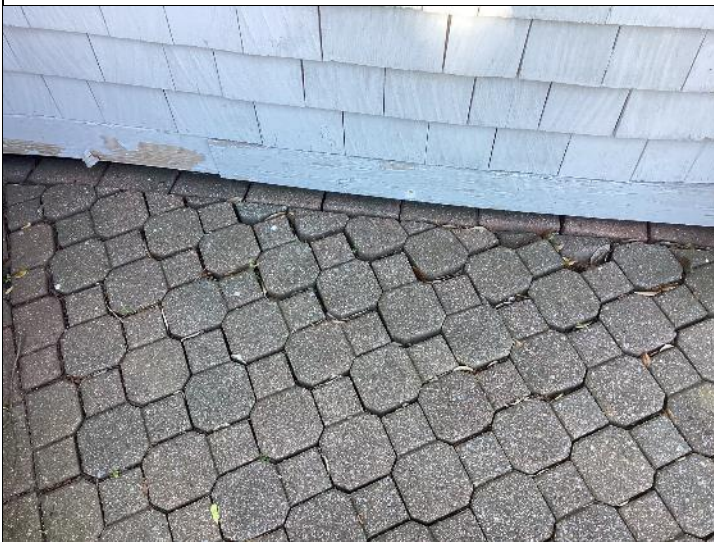
Photo #20: Some of the pavers have begun to settle and separate. Consideration should be given to applying a fine sand to the openings to help hold the walk together.

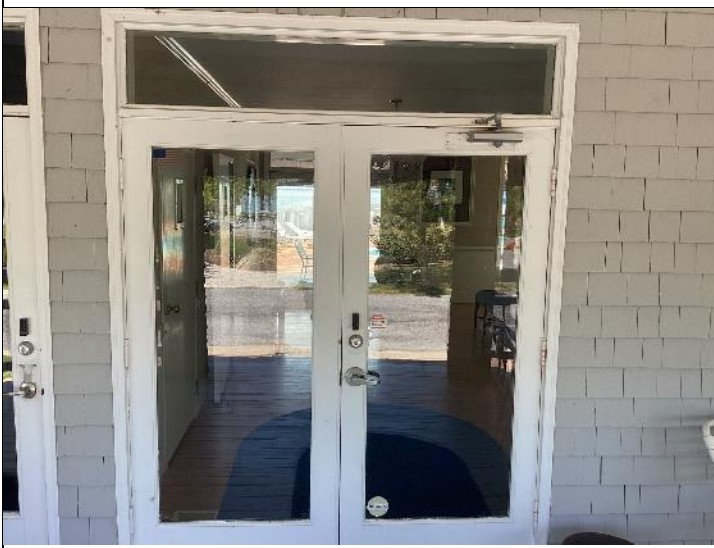
Photo #21: Community building entry.

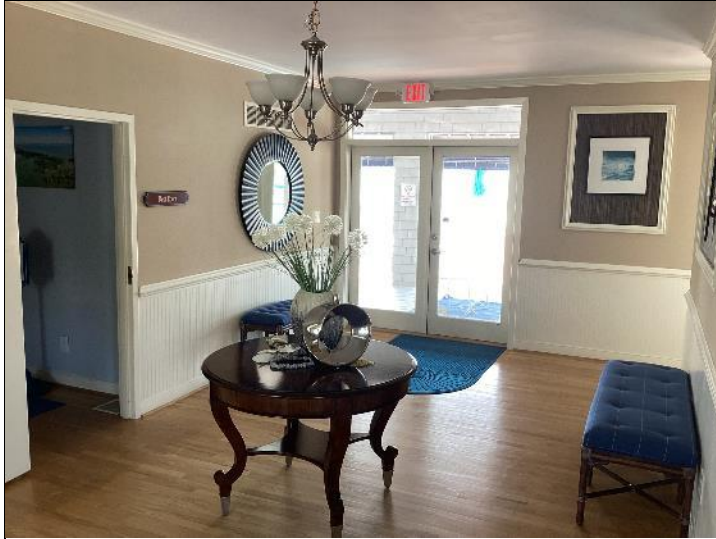
Photo #22: Typical interior finishes.

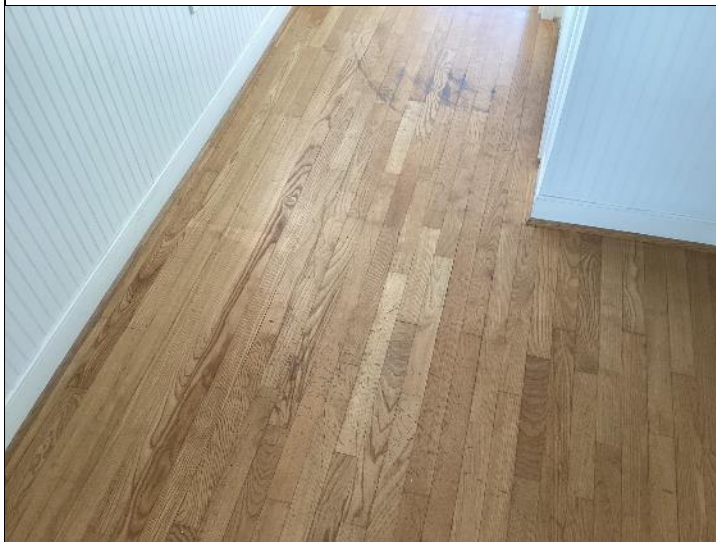
Photo #23: The hardwood flooring should be refinished on a cyclical basis.

Chart Item	Repair/Replacement Description
1. Wood Floors - Refinishing	The estimated replacement cost for wood floor is based on sanding the floor, replacing small portions of deteriorated wood, and application of two coats of high wear varnish or polyurethane.

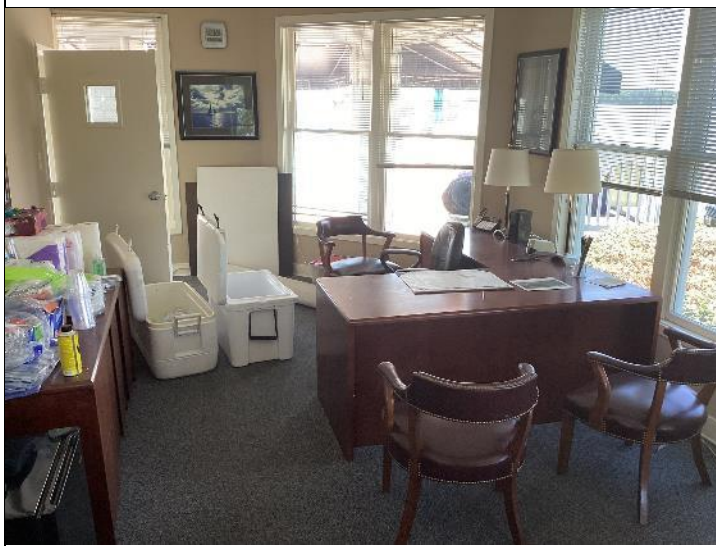
Photo #24: Management office.

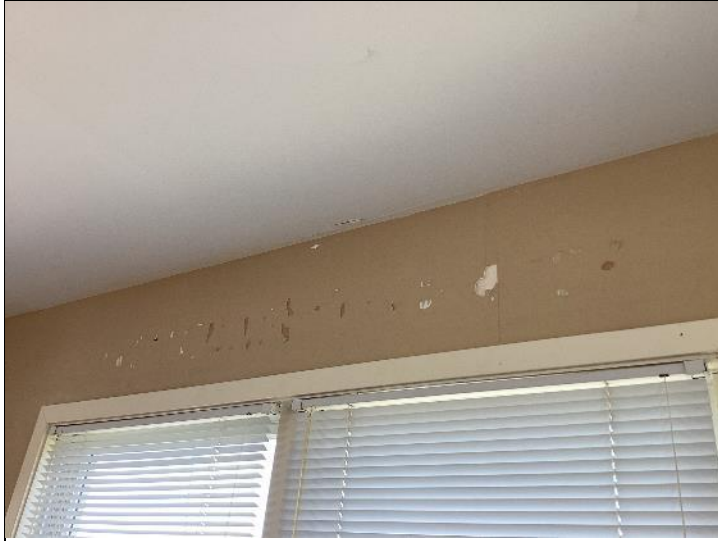
Photo #25: Damages noted to some of the interior wall finishes. Consideration should be given to repainting these areas.

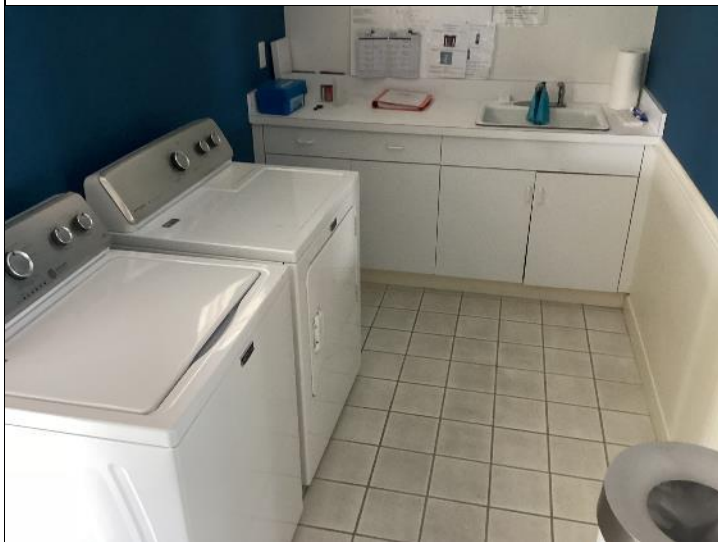
Photo #26: Laundry area.

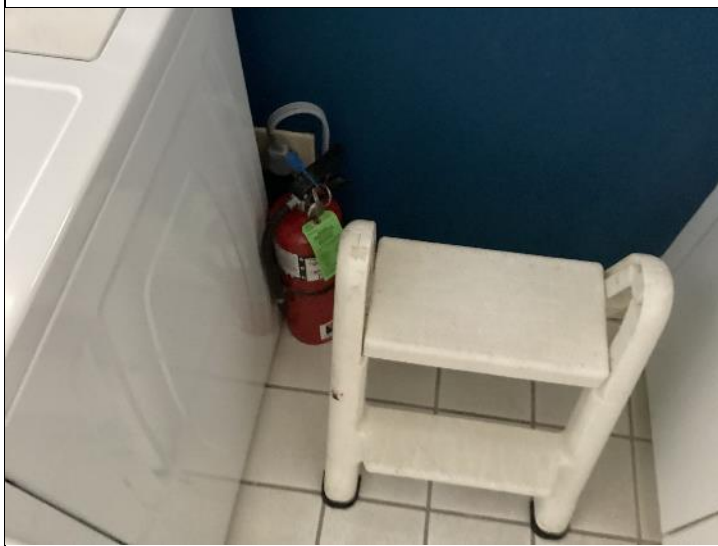
Photo #27: Fire extinguishers are required to properly mounted per fire code regulations.

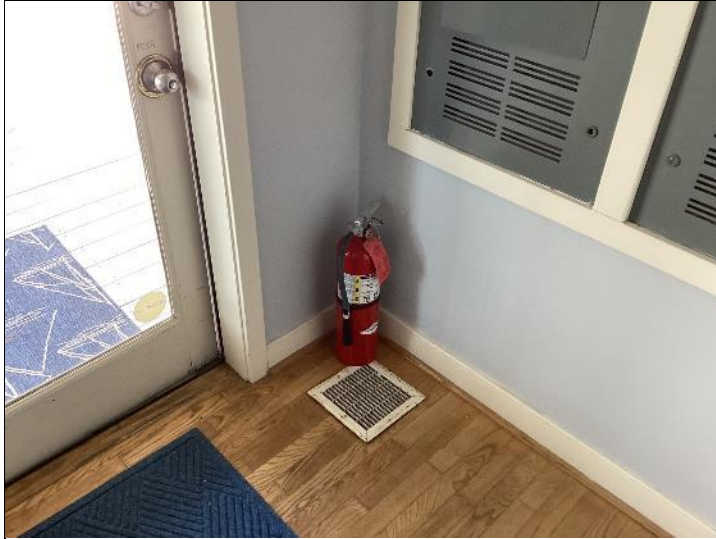
Photo #28: Fire extinguishers are required to properly mounted per fire code regulations.

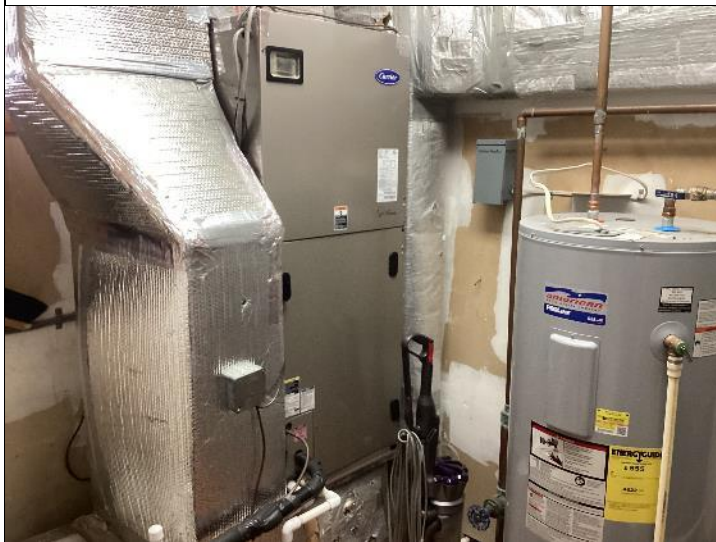
Photo #29: HVAC and water heater servicing the community building.

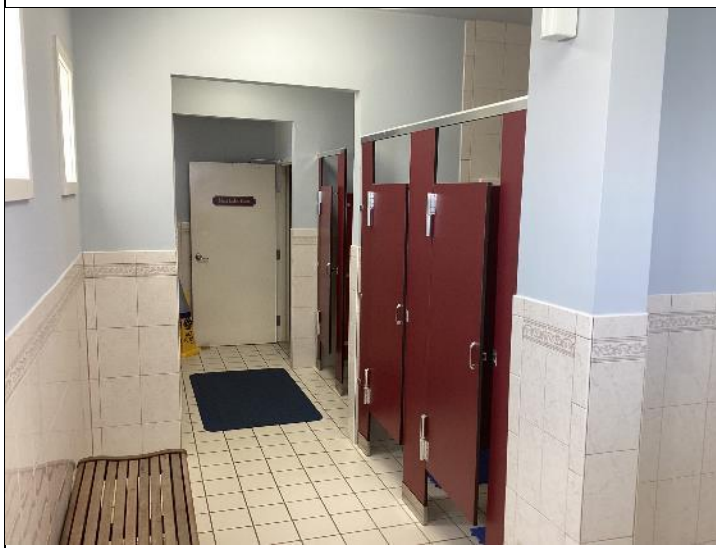
Photo #30: Typical bathroom finishes. The bathrooms presented in good condition during our review.

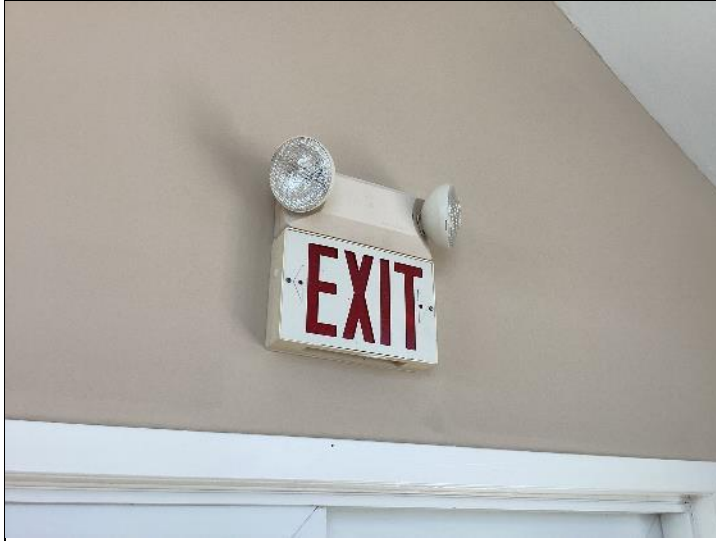
Photo #31: Some exit lights were inoperable during our review. We recommend they be tested and replaced where needed.

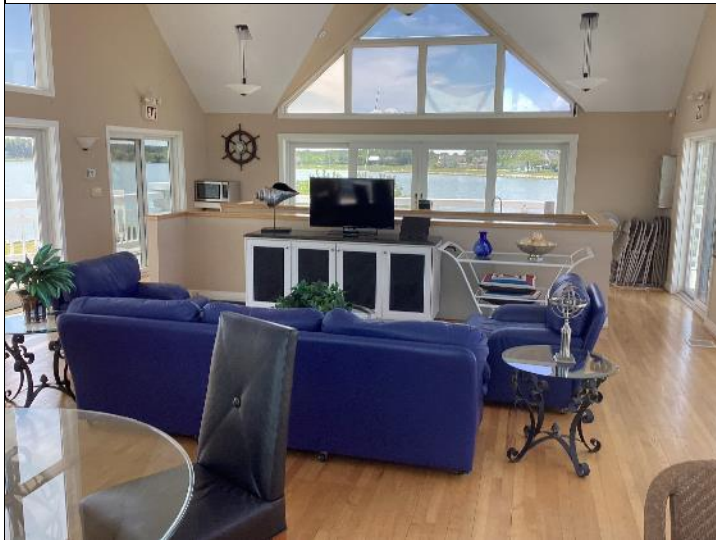
Photo #32: Community building top floor furnishings and finishes.

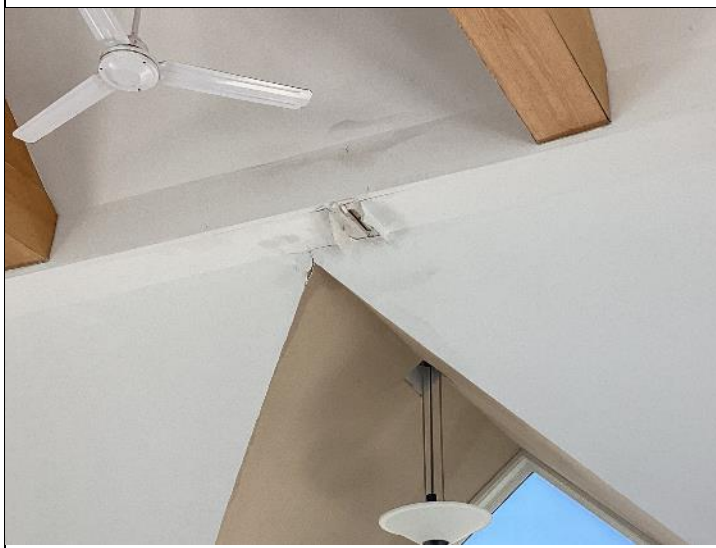
Photo #33: Apparent water damage was noted in the ceiling of the community building. We recommend this be monitored and repaired accordingly.

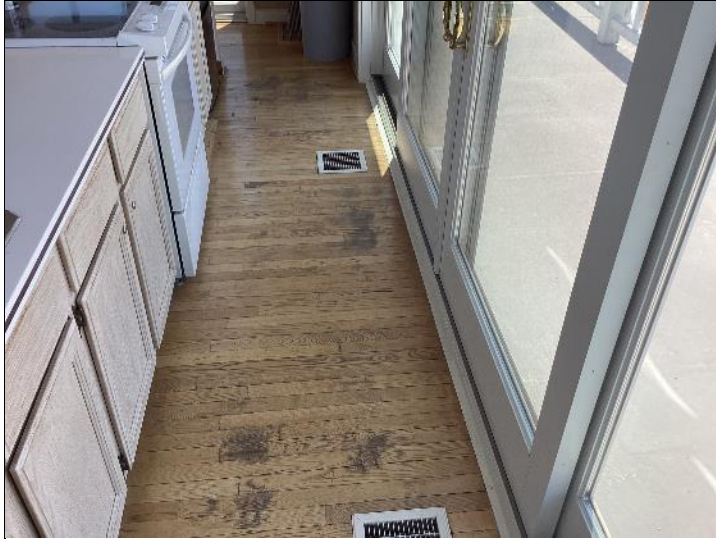
Photo #34: The hardwood flooring should be refinished on a cyclical basis.

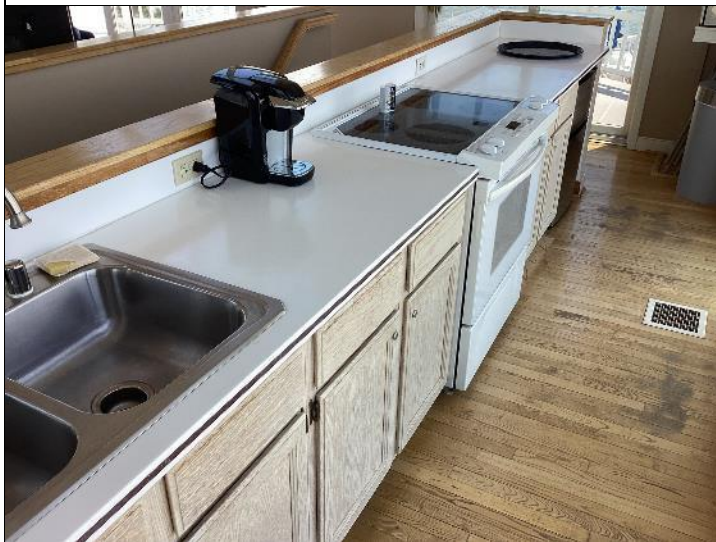
Photo #35: Community building kitchenette.

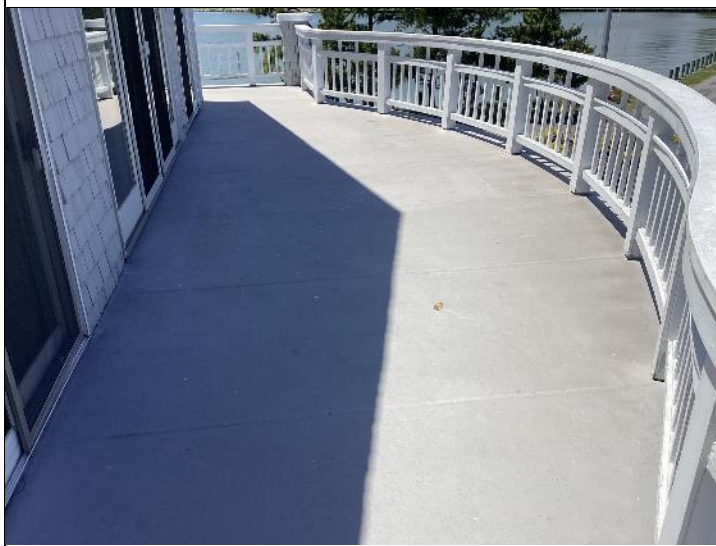
Photo #36: Duradek roofing material.

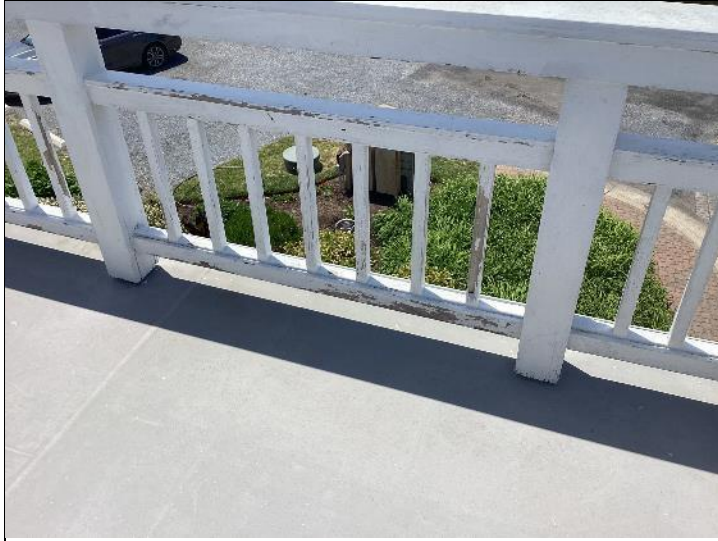
Photo #37: We recommend the railings be properly prepared and painted.

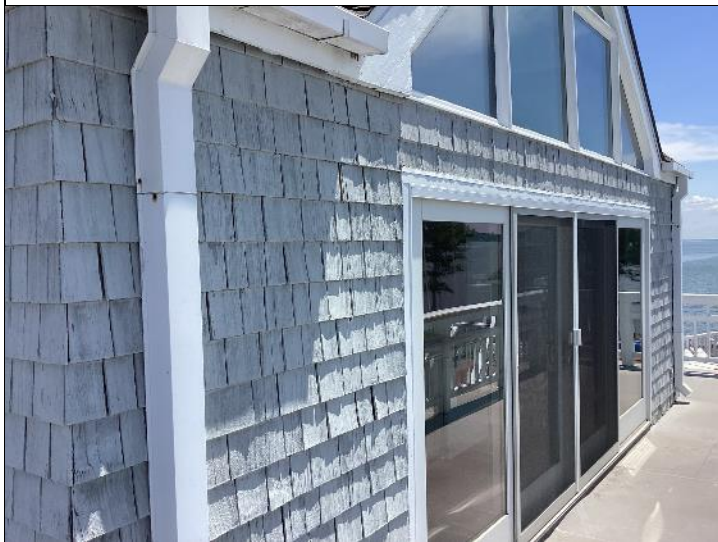
Photo #38: The exterior siding is scheduled for replacement.

5. Shake Siding - Hardie Replacement	Hardie Plank siding is a cement-fibrous material. It has a longer life expectancy than vinyl siding by about three times and is approximately three times the cost. The estimated replacement cost is based on replacing this siding with new siding of similar materials.

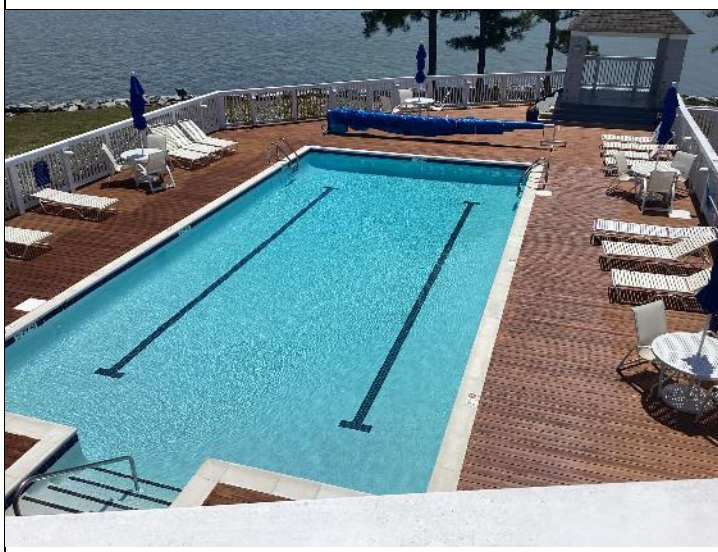
Photo #39: Pool

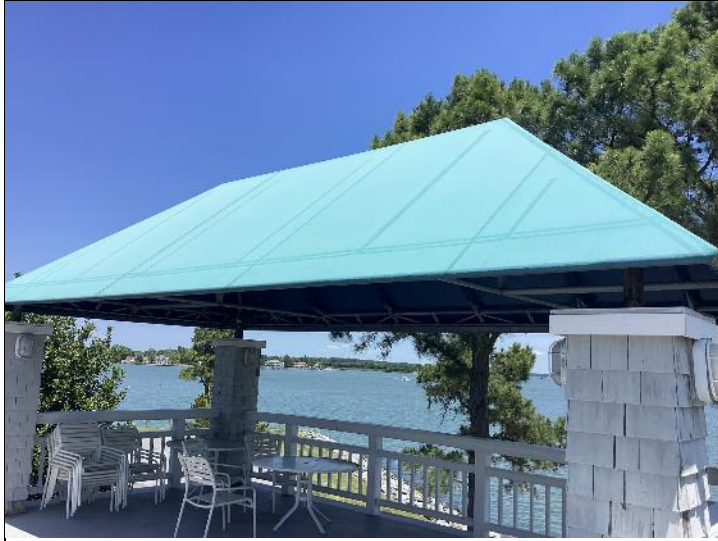
Photo #40: The awning has faded, but otherwise presented in acceptable condition.

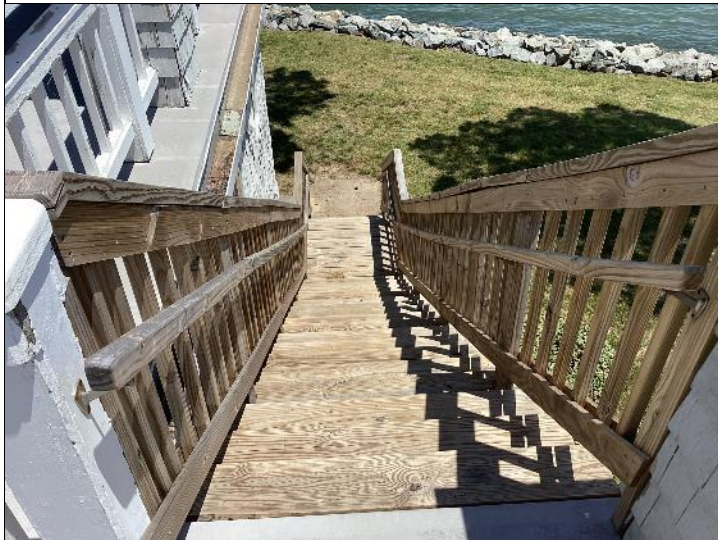
Photo #41: Community building egress stairs.

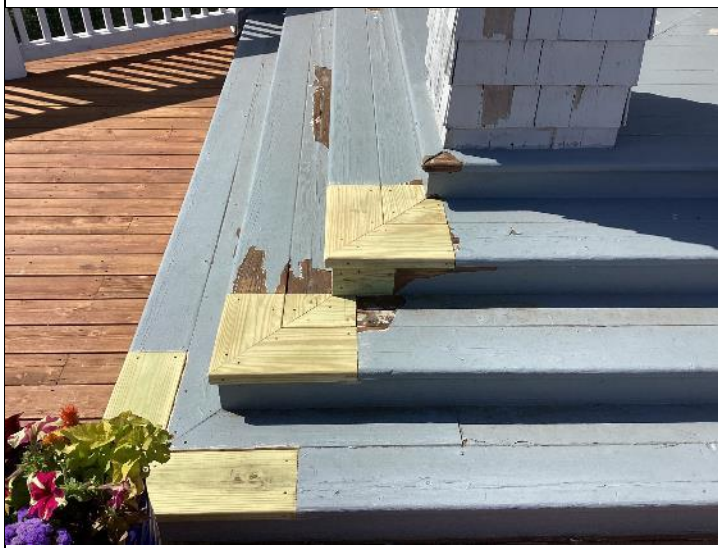
Photo #42: Repairs made to the decking.

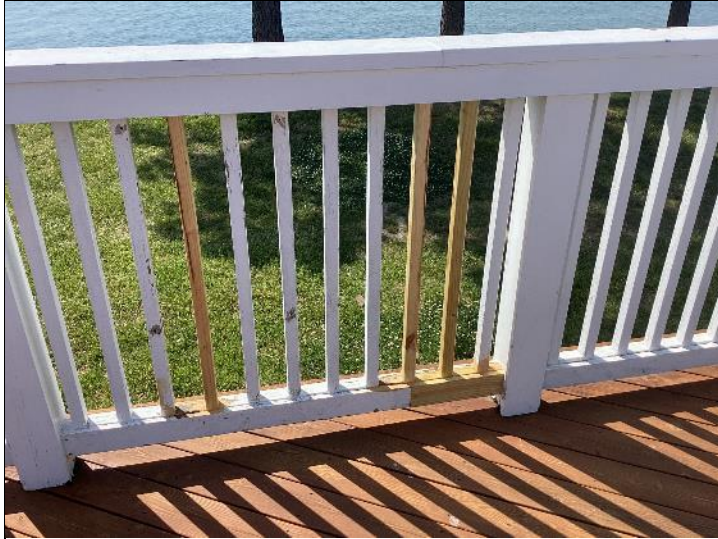
Photo #43: Repairs made to the wood railings.

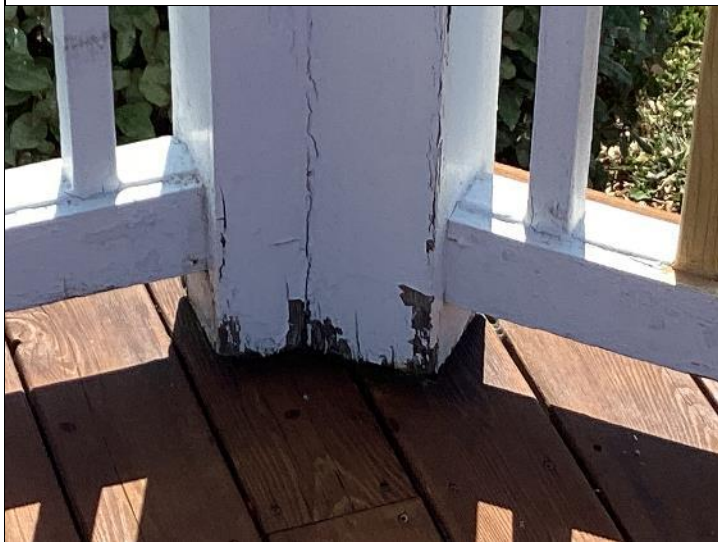
Photo #44: Consideration should be given to properly preparing and painting the wood railings on a cyclical basis to preserve the wood.

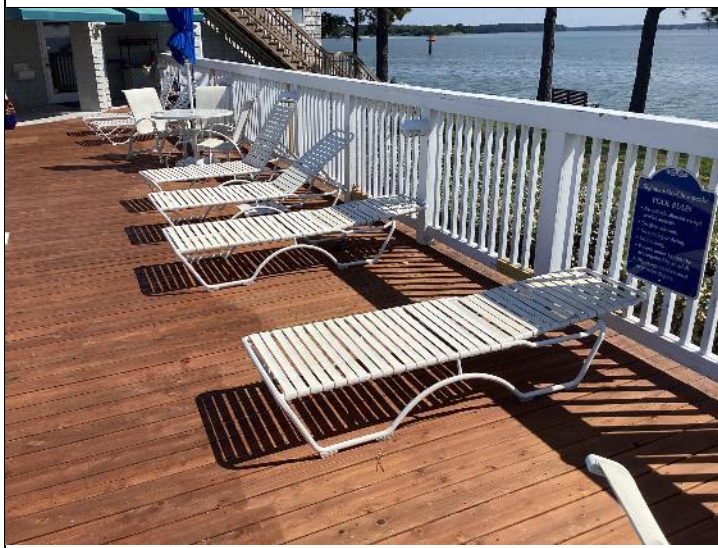
Photo #45: Pool furnishings.

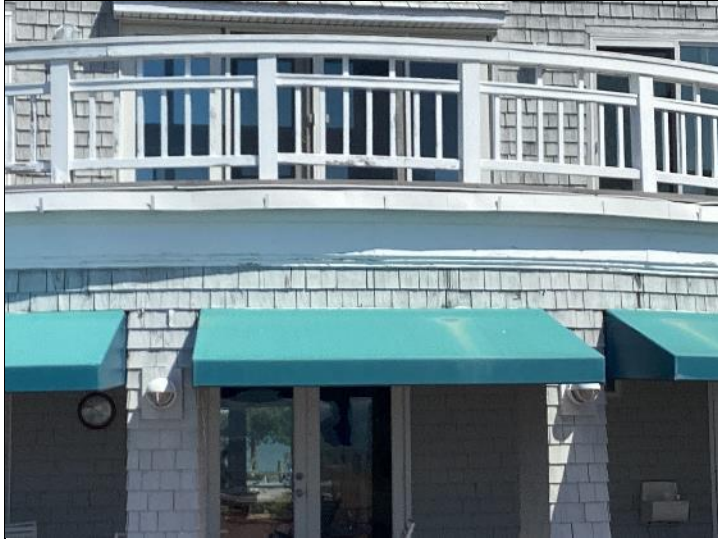
Photo #46: Community buildings awnings.

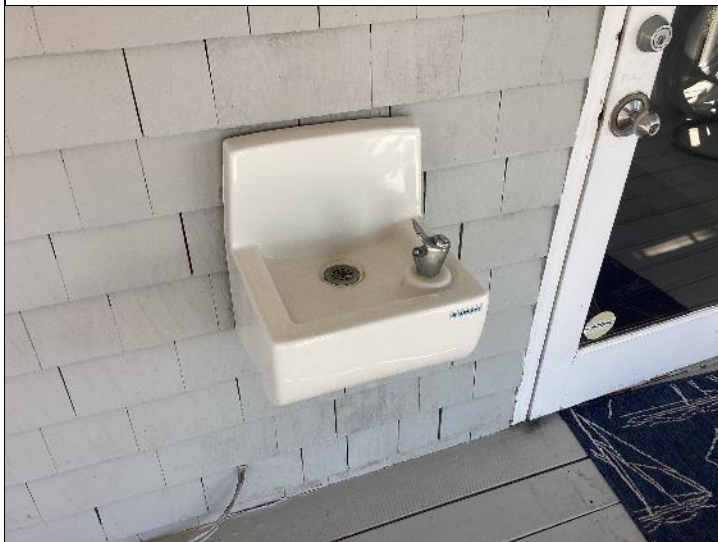
Photo #47: Drinking fountains.

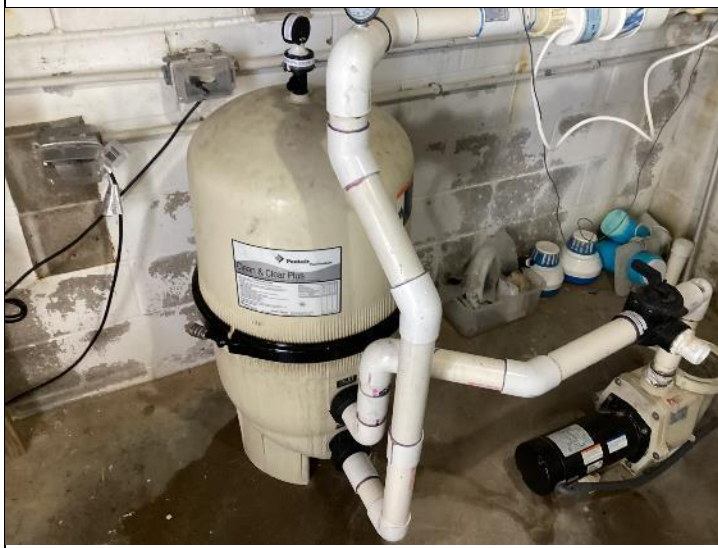
Photo #48: Pool filter and pump.

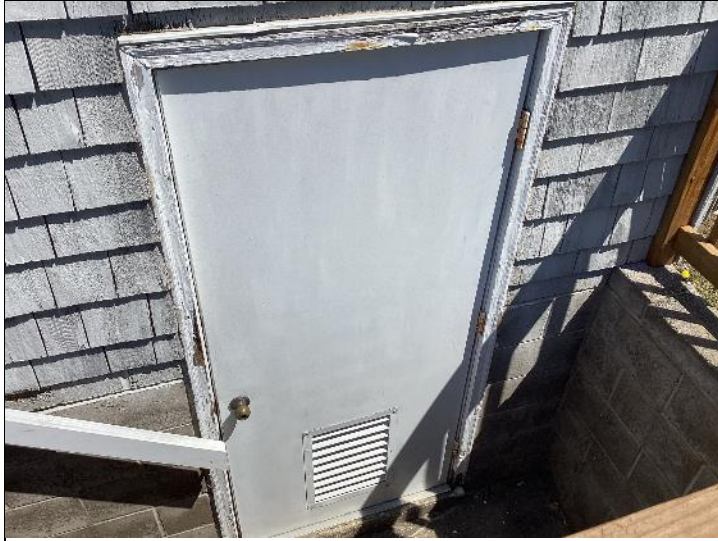
Photo #49: Pool mechanical room door.

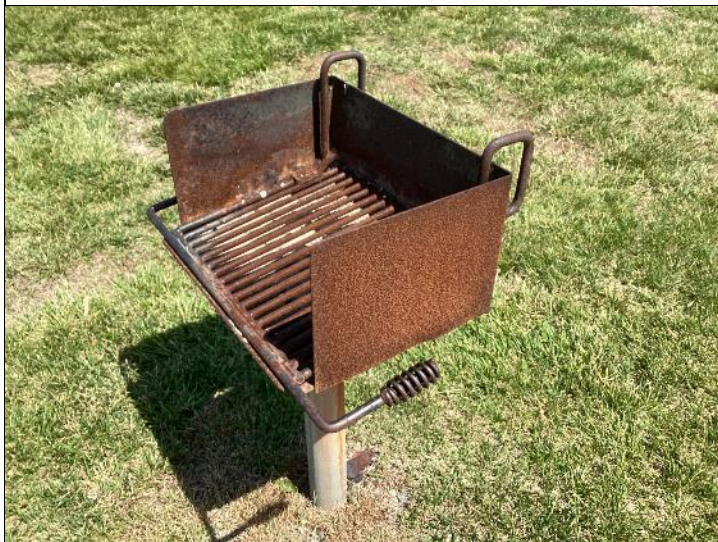
Photo #50: The stationary grills have oxidized. Consideration should be given to painting these on a cyclical basis to preserve the metal.

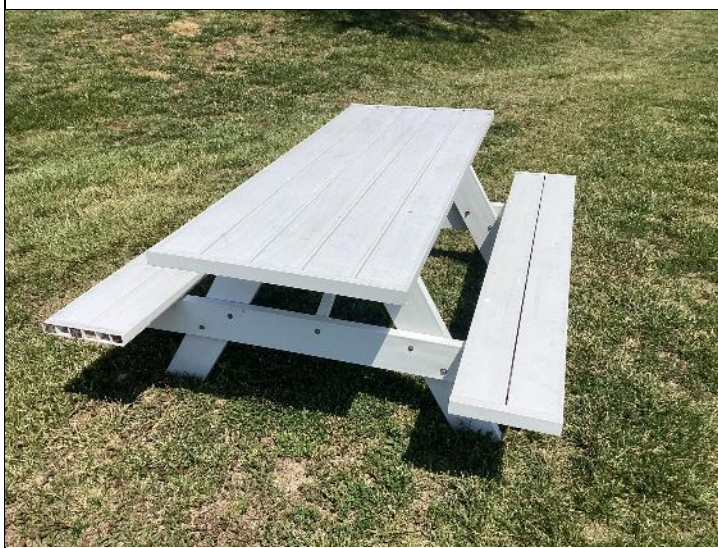
Photo #51: Picnic table.

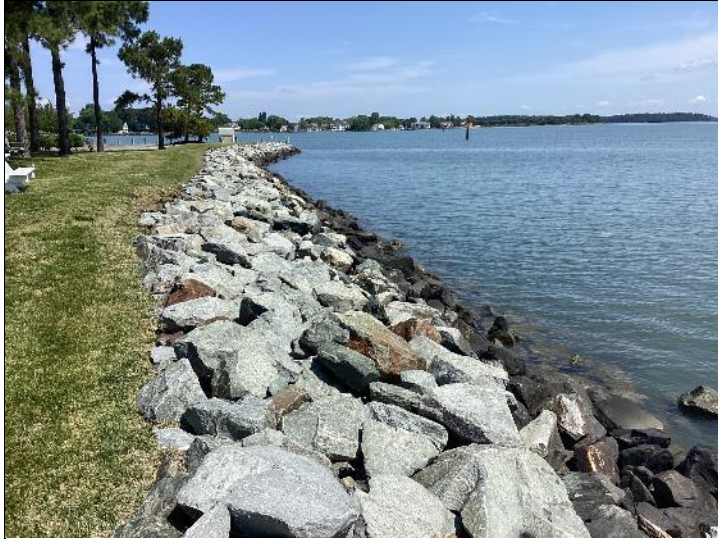
Photo #52: Shoreline riprap. This is likely life of property. A small allowance has been added for maintenance of this seawall.

18. Shoreline Riprap - Allowance	An allowance has been added to the reserve schedule for maintenance of the shoreline riprap.
19. Jetty Replacement	The estimated replacement cost is for replacement of the existing jetty with a new jetty. It is anticipated that new jetty will be constructed of stone.

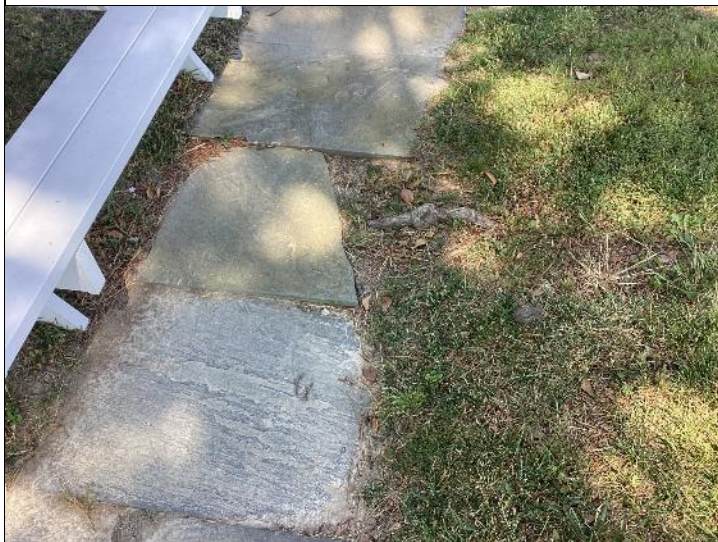
Photo #53: Damaged steppingstone paver.

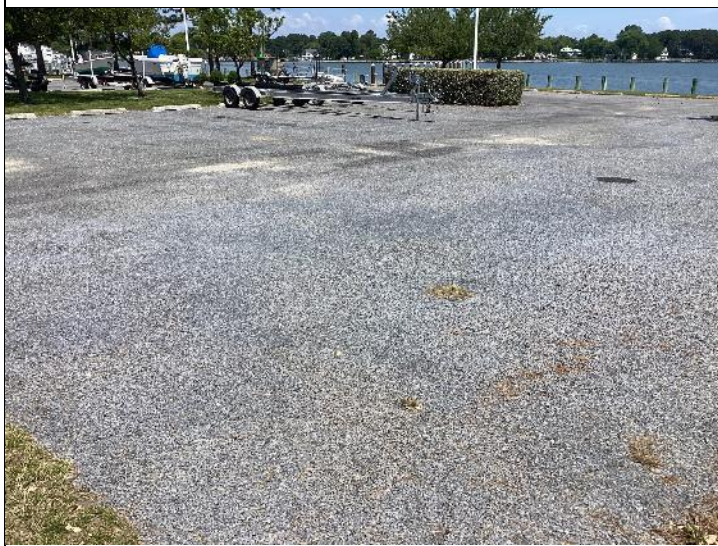
Photo #54: The asphalt should be considered for repaving.
